FAULT INSPECTION BY AERIAL INFRARED THERMOGRAPHY IN A PV PLANT AFTER A METEOROLOGICAL TSUNAMI

Figure 1 - 3 MWp PV Plant in Tubarão-Santa Catharina, South of Brazil.

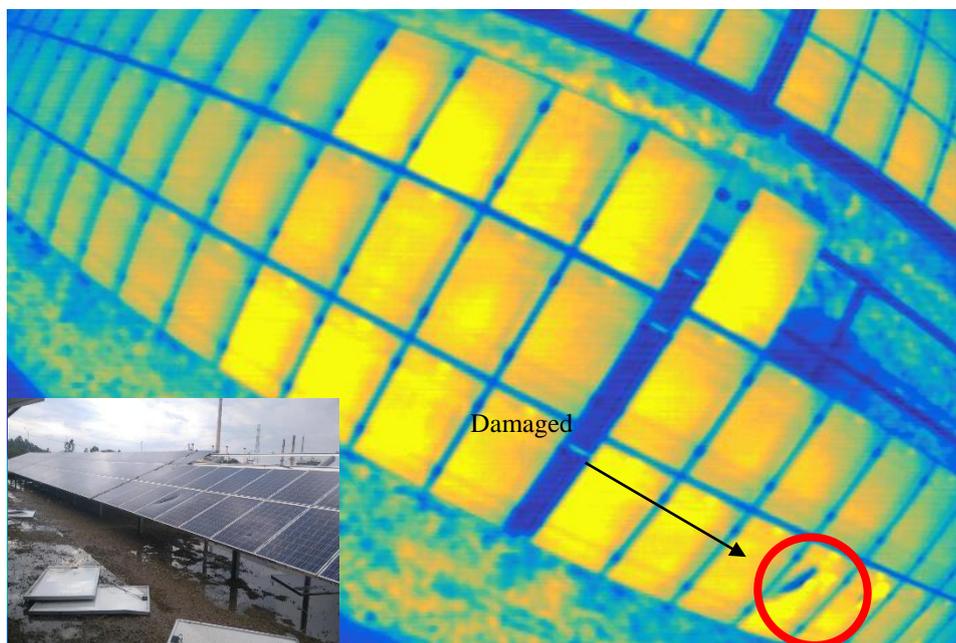
Fig. 4 shows an example of a damaged PV module detected. It also shows some missing modules that were swept away by the wind, hitting and damaging other PV modules. Consequently, the PV module string with missing modules, and the string with the damaged module were both open-circuited. Both strings became uniformly warmer than the others, and were easily and immediately detected using the IRT drone. Other open-circuited strings that have been detected are shown in Fig. 5 and Fig. 6.

Figure 4 – Damaged PV module pictured by the IRT drone system and by a conventional camera.

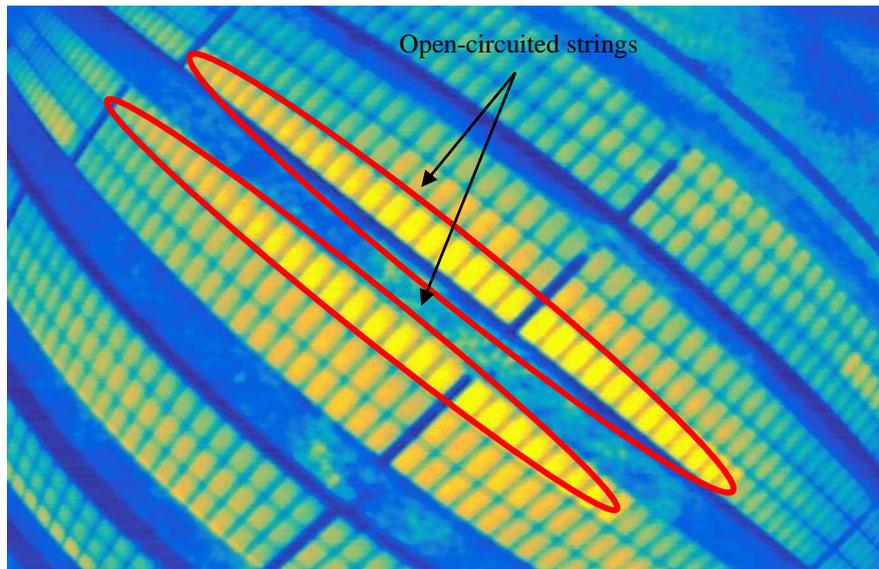
Figure 5 – Open-circuited strings by the IRT drone system.

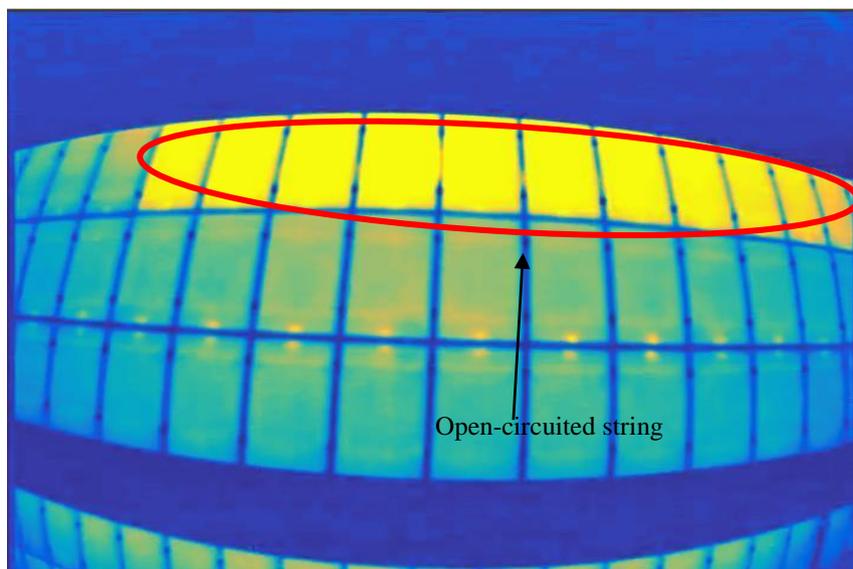
Figure 6 – Open-circuited string image taken with the IRT drone system

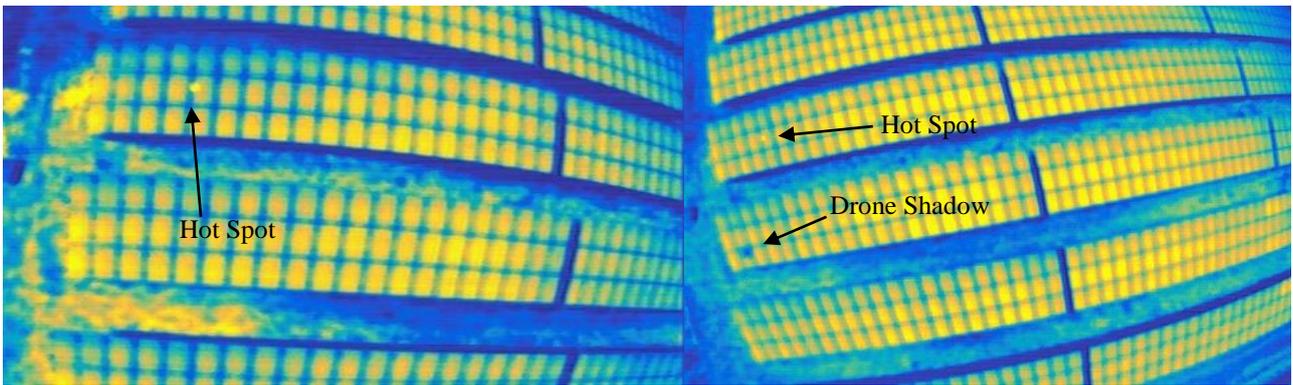
Some hot spots could also be detected after the meteorological incident. One of them is seen in Fig. 7, which presents two images taken from different heights. They illustrate how faults can be identified even from high altitudes, allowing the IRT system operator to investigate several modules at the same time. With the experiment, there were hot spots that could be detected even when the UAV was flying at 40 m of altitude. Nevertheless, as previously mentioned, it is important to maintain a certain altitude that will preserve the quality of the image, capturing all the PV cells. In the right picture in Fig.7, another point stands out: the shadow caused by the drone itself. It is important to differentiate such reflections as well as reflections from the sun or other objects from actual potential problems in PV system IR images, otherwise incorrect conclusions can be drawn. The module with the hot spot was individually analyzed and replaced.

Figure 7 - Hot spot image taken from two different heights with the IRT system.

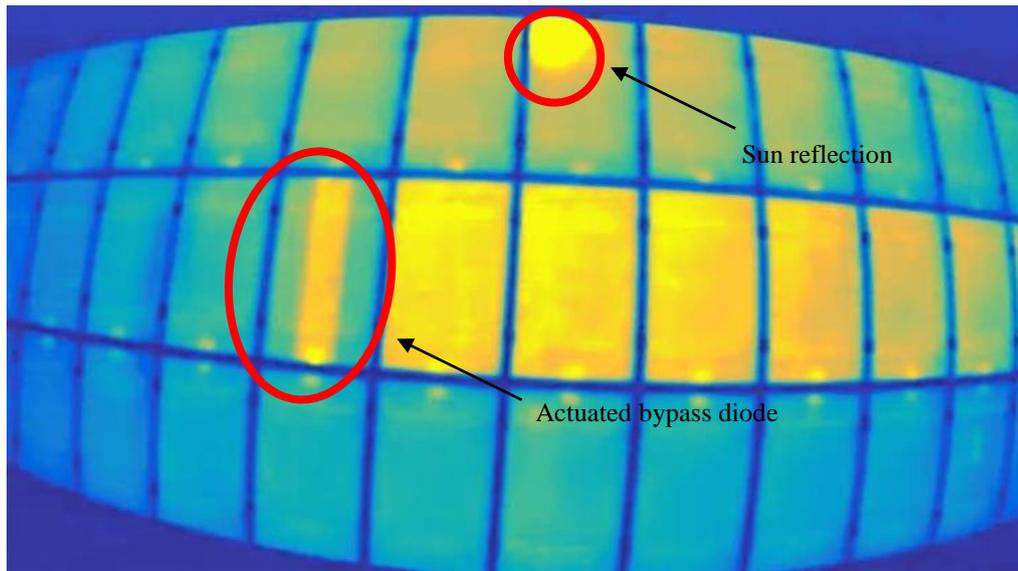
Another relevant fault detection issue, made possible using the IRT system, was an actuated bypass diode in one of the three cell strings of an individual PV module, as displayed in Fig. 8. The figure shows that the two middle rows of a PV module are warmer than the other four (PV modules typically have six rows of either 10 or 12 cells each, with each two rows protected by one bypass diode). On the right hand side of this module, another open-circuited string was detected. It is important to notice that the brighter areas on the upper modules of the array are caused by sun reflection, and not by a module fault.

Figure 2 – Actuated bypass diode detected with the IRT system.

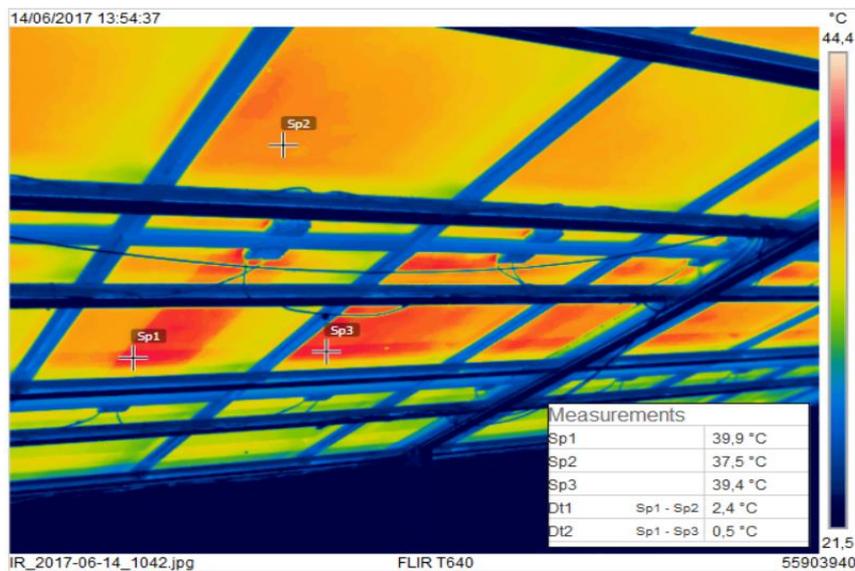
The same modules were also analyzed with the hand-held IR-camera Flir T640, as shown in Fig. 9. The increase in temperature of the module with the actuated bypass diode reaches 2.4 degrees and is slightly higher (0.5 degrees) than the modules of the open-circuited string. That is a certainly low difference of temperature between normal cells and injured ones, and it still could be distinguished.

Figure 9 – Actuated bypass diode picture taken with FLIR T640, seen from the back of the module.

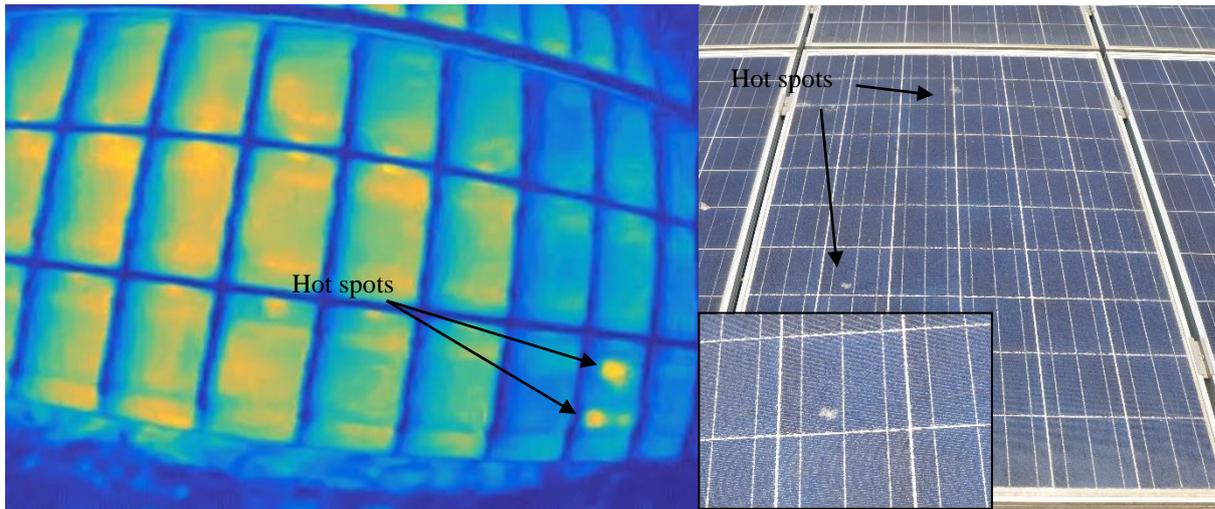
Fig. 10 also shows some hot spots detected, accompanied by pictures taken with a conventional camera. Most of the hot spots correspond to broken modules as this case. Even though the cracks are visible with a conventional camera, they are much more prominent in pictures taken with the IRT system and therefore are faster detected. Fig. 11 displays a picture of the same damaged module, but taken with the FLIR T640, presenting the differences of temperatures

Figure 10 – Hot spots detected with the IRT system.

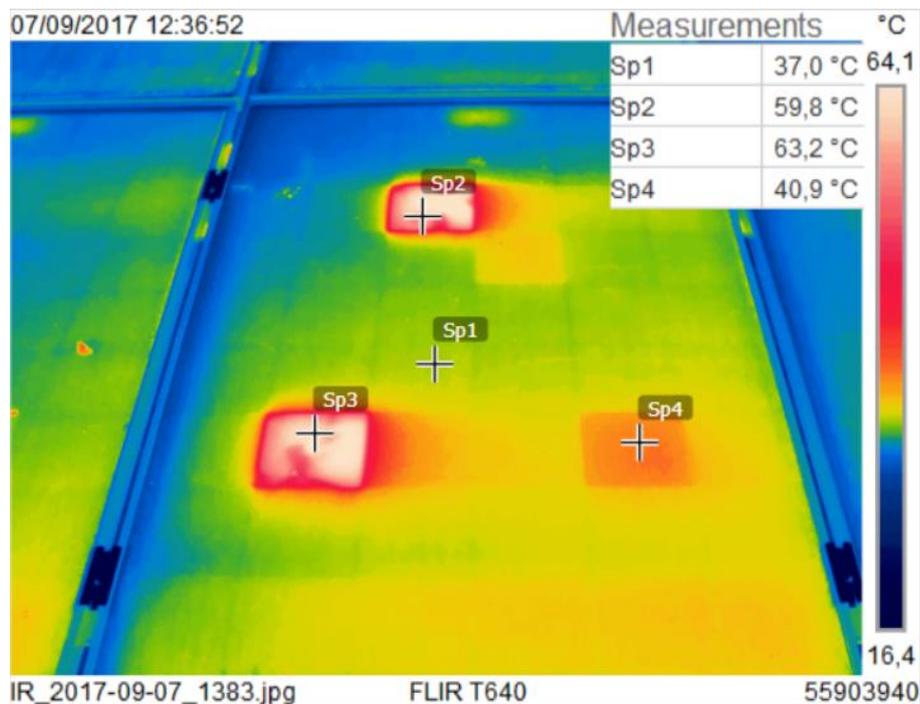
between cells. In this case, the difference of temperature between the cell and the hot spots is much higher than in Fig. 9, achieving 26.2° . This kind of temperature abnormality is seriously dangerous and should be detected and corrected in order to avoid fires.

Figure 11 – Hot spots picture taken with FLIR T640.
